Spare parts for EURO20 NG DN150 (standard and reinforced versions)

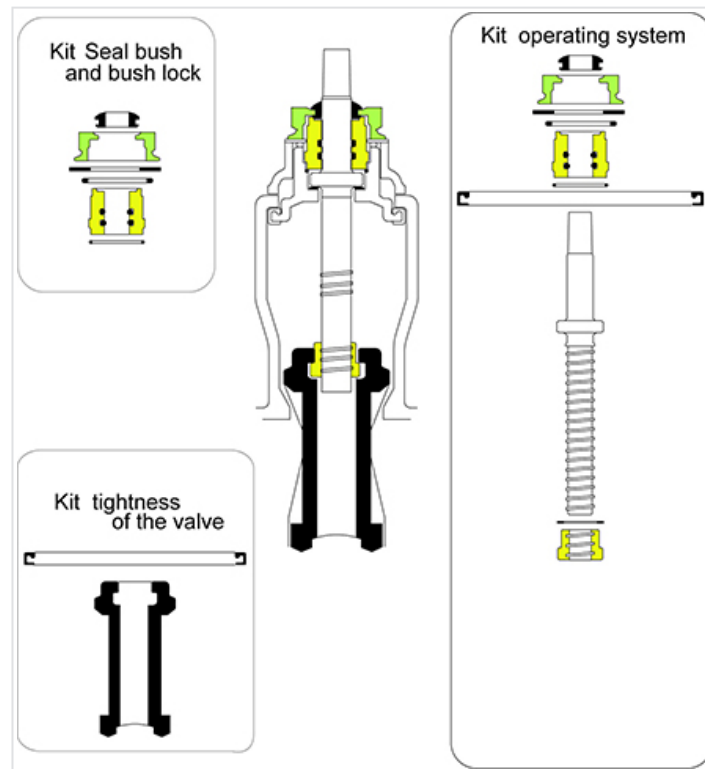
All types since 2003 DN150	Standard Version		Reinforced Version	
	References anti clockwise	References clockwise	References anti clockwise	References clockwise
Kit seal bush and bush lock (5 sets)	182071 up to end 2010 182072 from 2011	182072	-	182073
Kit tightness of the valve (5 sets)	182196	182196	182196	182196
Kit operating system	182200 up to end 2010 225011 from 2011	182201	-	182201

Warning: from beginning of 2011, for anti-clockwise valves, the screw V24 has been replaced by the screw V26
